INDOOR AIR QUALITY ASSESSMENT

**Foster Elementary School
55 Downer Avenue
Hingham, MA 02043**

Prepared by:
Massachusetts Department of Public Health
Bureau of Environmental Health
Indoor Air Quality Program
March 2008

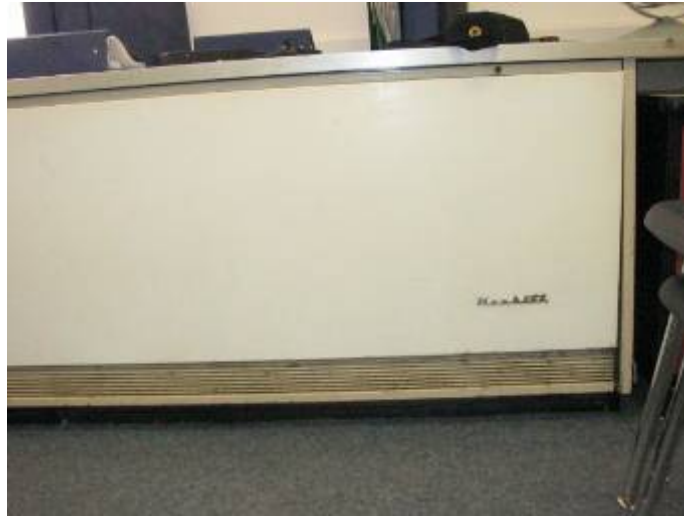
Picture 1

Fresh air is supplied to classrooms by unit ventilator (univent) systems (Picture 1). A univent is designed to draw air from outdoors through a fresh air intake located on the exterior wall of the building (Picture 2) and return air through an air intake located at the base of each unit ([Figure 1](#)). Fresh and return air are mixed, filtered, heated and provided to classrooms through a fresh air diffuser located in the top of the unit. Obstructions to airflow such as items on univents and/or furniture in front of univent returns were observed in a large number of classrooms (Pictures 3 and 4).

Classroom Univent

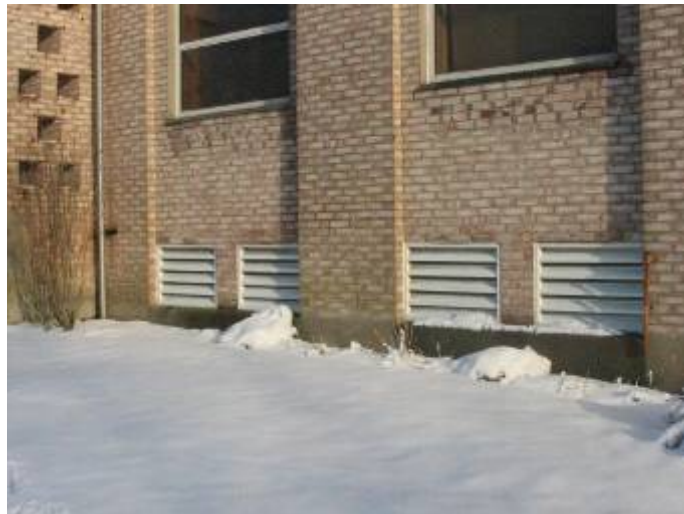
Picture 2

Plants were also growing in close proximity to the building (Picture 2). The growth of roots against exterior walls can bring moisture in contact with the foundation. Plant roots can eventually penetrate, leading to cracks and/or fissures in the sublevel foundation. Over time, this process can undermine the integrity of the building envelope,

Fresh Air Intake, Garden in front of Intake

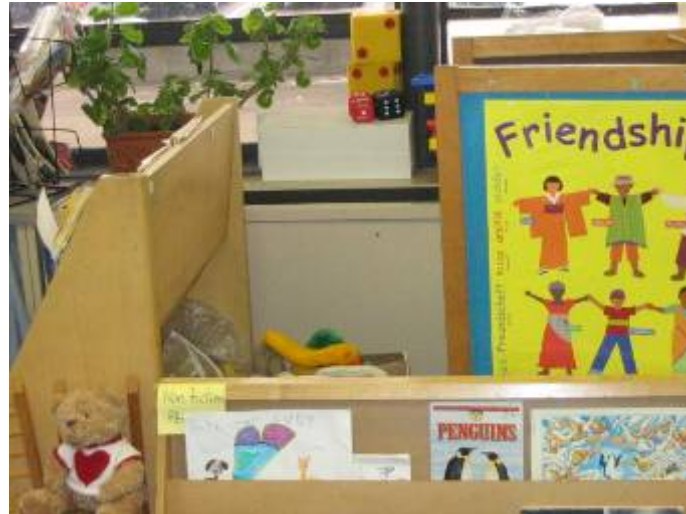
Picture 3

Furniture and Items Obstructing Univent

2. Remove all blockages from univents and exhaust vents to ensure adequate airflow. Consider reconfiguring the layout of some classrooms to facilitate airflow.

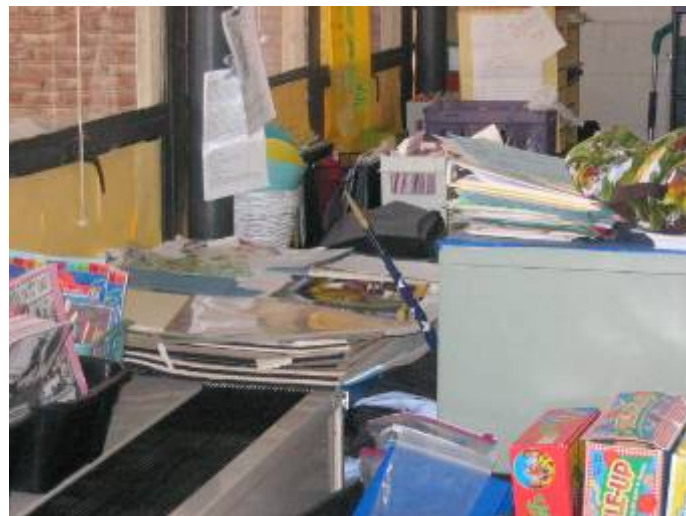
Picture 4

Items Obstructing Univent

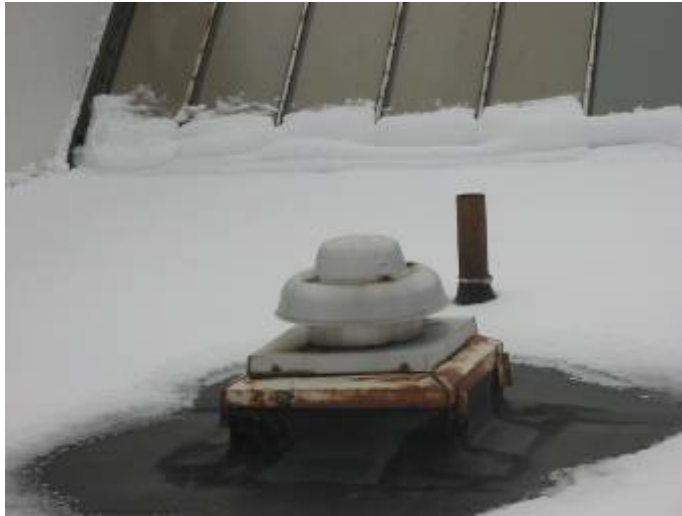
Picture 5

Exhaust ventilation in classrooms is provided by unit exhaust ventilators and/or wall- or ceiling-mounted vents ducted to rooftop motors (Picture 5). A unit exhaust ventilator appears similar to a univent, but removes air from the classroom and exhausts it out of the building. Many unit exhaust ventilators were enclosed in univent casing (Picture 6); therefore, the unit exhaust vents were equipped with a fresh air diffuser on top of unit, allowing dirt, dust and other materials to fall down into the motor. Several unit exhaust vents were obstructed by items and/or furniture (Picture 7). In addition, several exhaust vents were deactivated at the time of the assessment. The location of some wall-mounted exhaust vents (i.e. above hallway door) can limit exhaust efficiency (Picture 8). When a classroom door is open, exhaust vents tend to draw air from both the hallway and the classroom. The open hallway door reduces the effectiveness of the exhaust vent to remove common environmental pollutants from classrooms. As with univents, in order to function properly, exhaust ventilation must be activated and allowed to operate while rooms are occupied. Without adequate supply and exhaust ventilation, excess heat and environmental pollutants can build up, leading to indoor air/comfort complaints.

Rooftop Exhaust

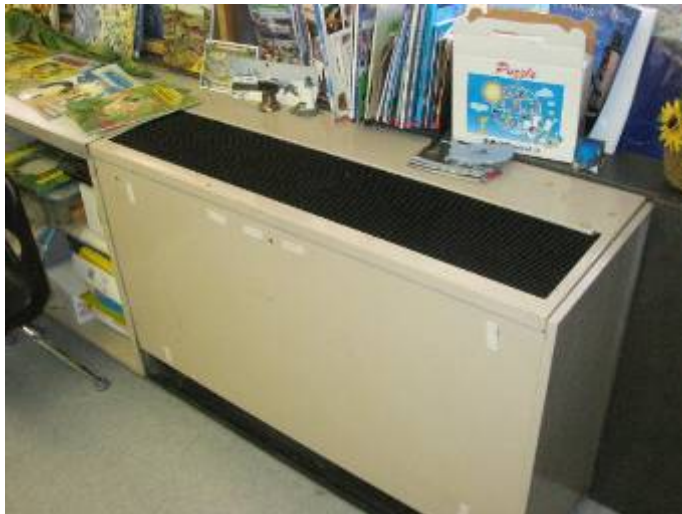
Picture 6

Unit Exhaust Ventilator, Note Air Diffuser on Top

3. Seal fresh air diffusers on all unit exhaust ventilators.
4. Ensure classroom doors are closed to maximize air exchange.
5. Use openable windows in conjunction with mechanical ventilation to facilitate air exchange. Care should be taken to ensure windows are properly closed at night and weekends to avoid the freezing of pipes and potential flooding.

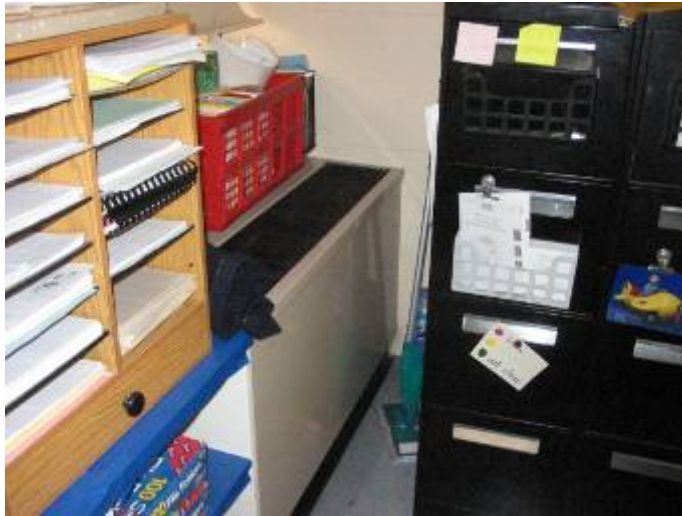
Picture 7

Exhaust vent obstructed by Furniture

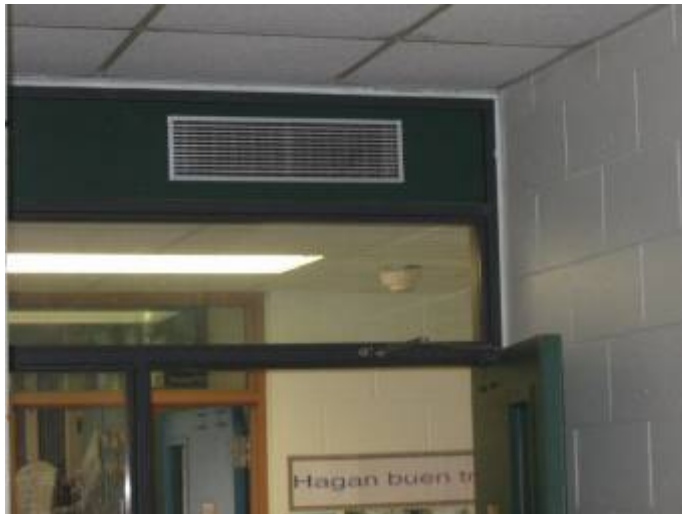
Picture 8

Exhaust located above hallway door

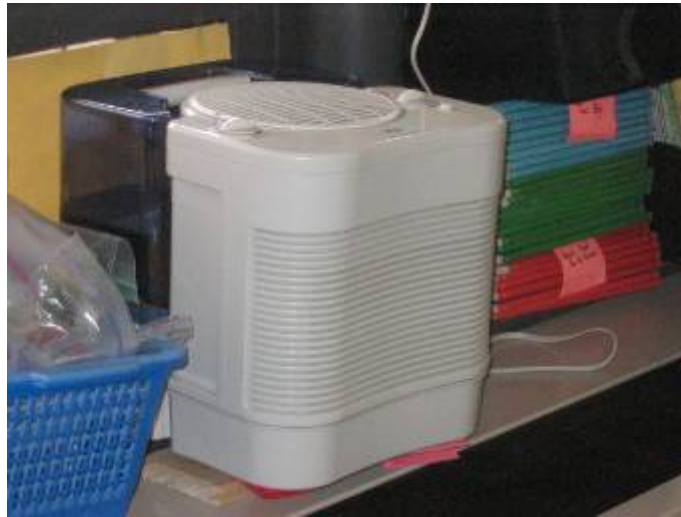
Picture 9

A humidifier was observed in a classroom (Picture 9). As with univents, humidifiers can aerosolize particles and odors. In addition, the water reservoirs can provide a source for mold growth. Water reservoirs for humidifiers should be cleaned as per manufacturer's directions to prevent microbial growth and odors. The air diffuser should also be cleaned periodically to prevent dust collection and aerosolization of materials.

Humidifier

9. Clean and disinfect humidifiers as per manufacturer's instructions (or more frequently as needed) to prevent microbial growth.
 10. Move plants away from univents in classrooms. Avoid over-watering and examine drip pans periodically for mold growth. Disinfect with an appropriate antimicrobial where necessary.

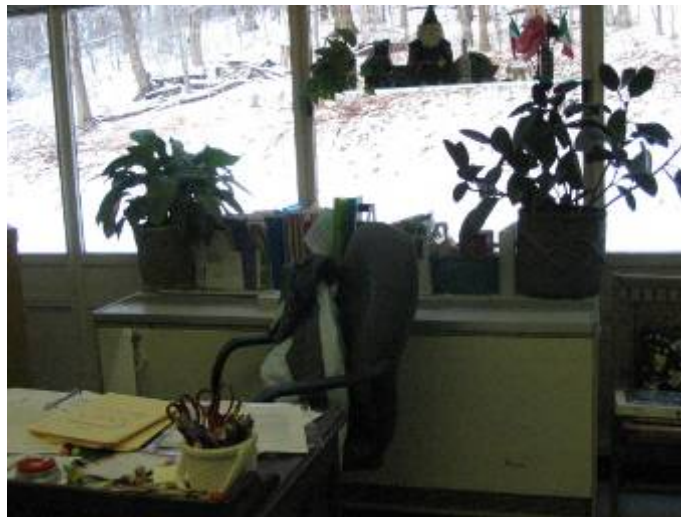
Picture 10

Plants were located in a number of classrooms (Pictures 3 and 10). Plants, soil and drip pans can serve as sources of mold growth, thus should be properly maintained. Over-watering of plants should be avoided and drip pans should be inspected periodically for mold growth. Plants should also be located away from univents to prevent aerosolization of dirt, pollen or mold.

Plants in Classroom; Note Close Proximity to Univent

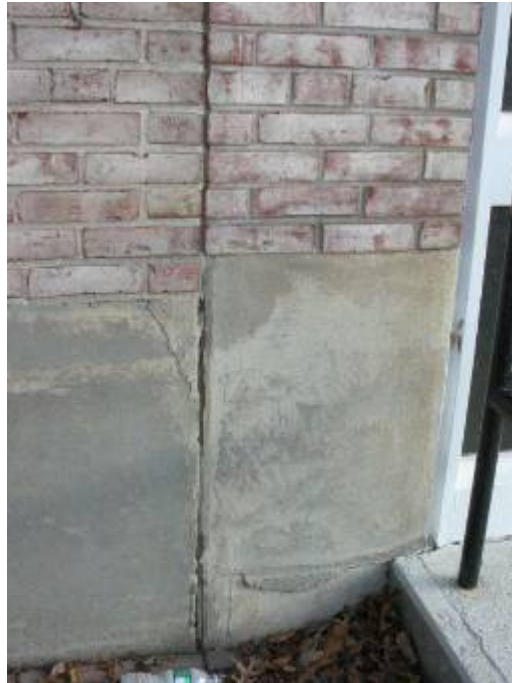
Picture 11

providing a means of water entry into the building via capillary action through foundation concrete and masonry (Lstiburek & Brennan, 2001). Damaged brickwork and missing/damaged mortar around masonry were also noted on the building exterior (Pictures 11 and 12). Breaches can provide a source of water penetration. To prevent water penetration, damaged brickwork should be re-pointed.

Cracked Brickwork

1. Contact an HVAC engineering firm for an assessment of the ventilation system’s control system (e.g., controls, air intake louvers, thermostats). Based on the age, physical deterioration and availability of parts for ventilation components, such an evaluation is necessary to determine the operability and feasibility of repairing/replacing the equipment.
2. Consider having exterior walls re-pointed and waterproofed to prevent water intrusion. This measure should include a full building envelope evaluation.

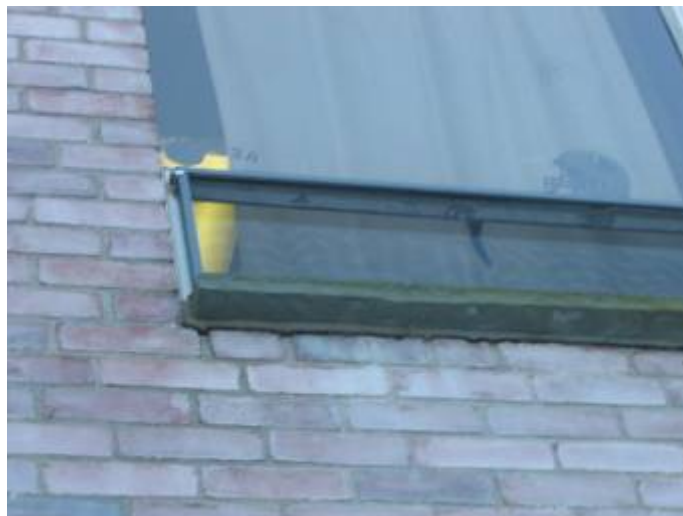
Picture 12

Missing and/or Damaged Mortar

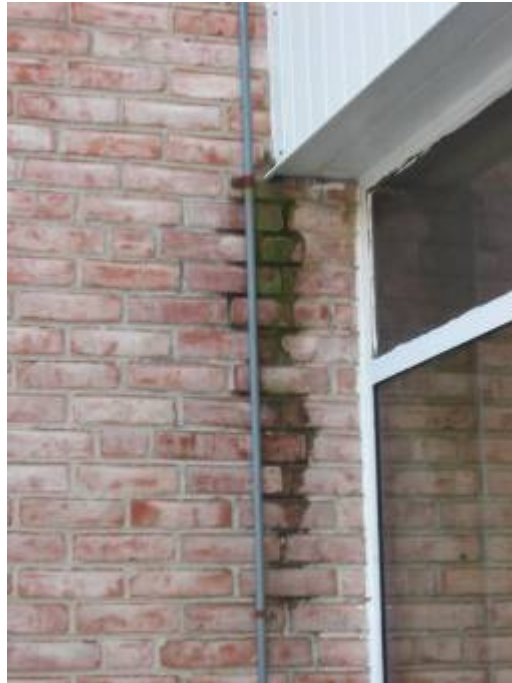
Picture 13

Exterior brickwork in several areas was visibly moist and had moss growth on the surface (Picture 13). A substantial source of water is needed for moss to grow. Moss growth is a sign of heavy/continuous water exposure which can undermine the structural integrity of the brick and mortar.

Moss Growth on Brickwork

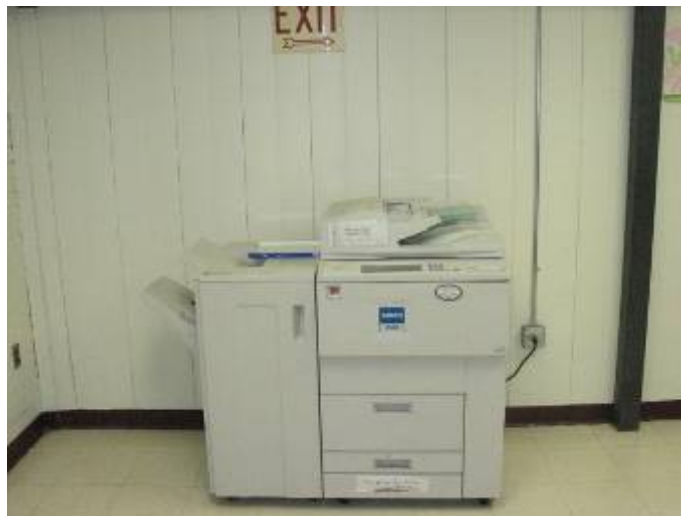
Picture 14

A photocopier was observed in a hallway (Picture 14). This area is not equipped with local exhaust ventilation to help reduce excess heat and odors. VOCs and ozone can be produced by photocopiers, particularly if the equipment is older and in frequent use. Ozone is a respiratory irritant (Schmidt Etkin, 1992).

Photocopier in Hallway

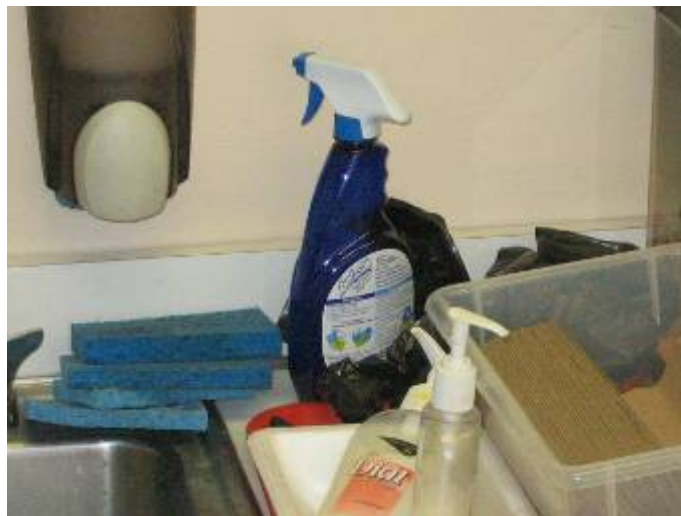
Picture 16

Cleaning products were also found on countertops and in unlocked cabinets beneath sinks in a number of classrooms. Like dry erase materials, cleaning products contain VOCs and other chemicals (Pictures 16). These chemicals can be irritating to the eyes, nose and throat and should be kept out of reach of students.

Cleaning Products

11. Store cleaning products properly and out of reach of students. Ensure spray bottles are properly labeled. *All* cleaning products used at the facility should be approved by the school department and MSDS' should be made available at a central location.

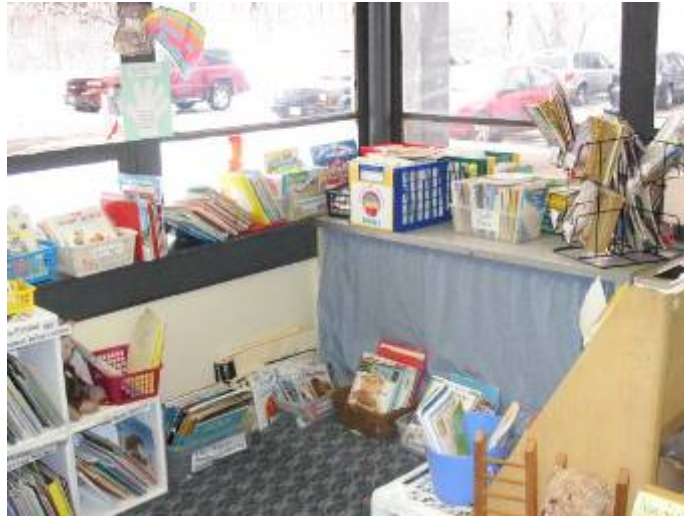
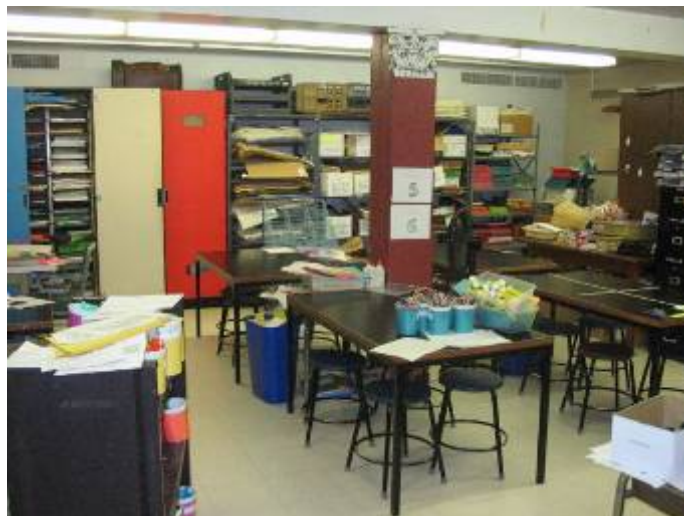
Picture 17

Other conditions that can affect indoor air quality were observed during the assessment. In several classrooms, items were observed on the floor, windowsills, tabletops, counters, bookcases and desks (Pictures 17 and 18). The large number of items

stored in classrooms provides a source for dusts to accumulate. These items (e.g., papers, folders, boxes) make it difficult for custodial staff to clean. Items should be relocated and/or be cleaned periodically to avoid excessive dust build up. In addition, these materials can accumulate on flat surfaces (e.g., desktops, shelving and carpets) in occupied areas and subsequently be re-aerosolized causing further irritation.

Accumulation of Items

12. Relocate or consider reducing the amount of materials stored in classrooms to allow for more thorough cleaning of classrooms. Clean items regularly with a wet cloth or sponge to prevent excessive dust build-up.

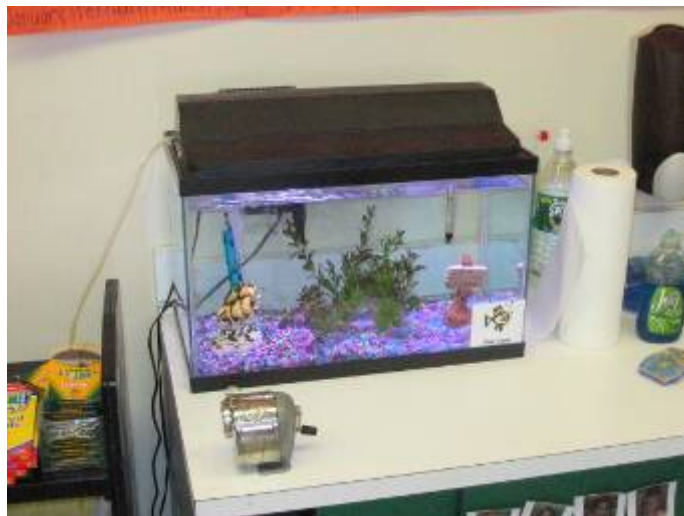
Picture 20

Several aquariums and terrariums were located in the classrooms (Picture 20). Aquariums should be properly maintained to prevent microbial/algal growth, which can emit unpleasant odors. Similarly, terrariums should be properly maintained to ensure soil does not become a source for mold growth.

Aquarium in Classroom

13. Clean personal fans, univent air diffusers, return vents and exhaust vents periodically of accumulated dust.
 14. Clean and maintain aquariums and terrariums to prevent mold growth and associated odors.

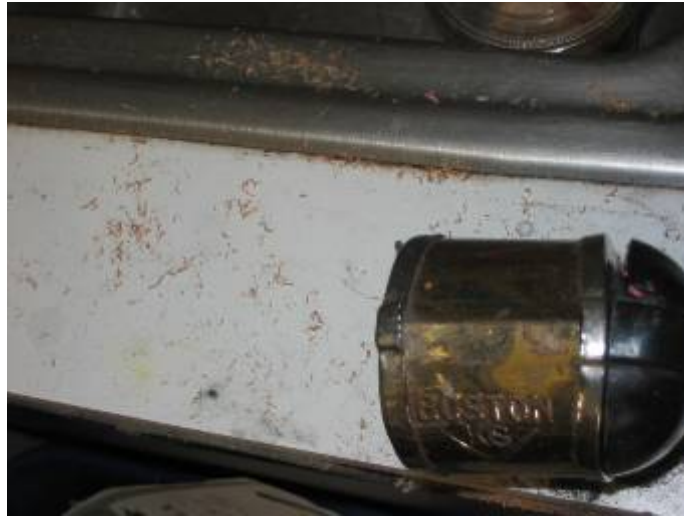
Picture 21

An accumulation of chalk dust and pencil shavings was observed in some classrooms (Picture 21). When windows are opened or univents are operating, these materials can become airborne. Once aerosolized, they can act as irritants to eyes and the respiratory system.

Pencil shavings and dust

15. Clean chalk and dry erase trays to prevent accumulation of materials.
 16. Nests should be placed in resealable bags to prevent aerosolization of allergenic material.

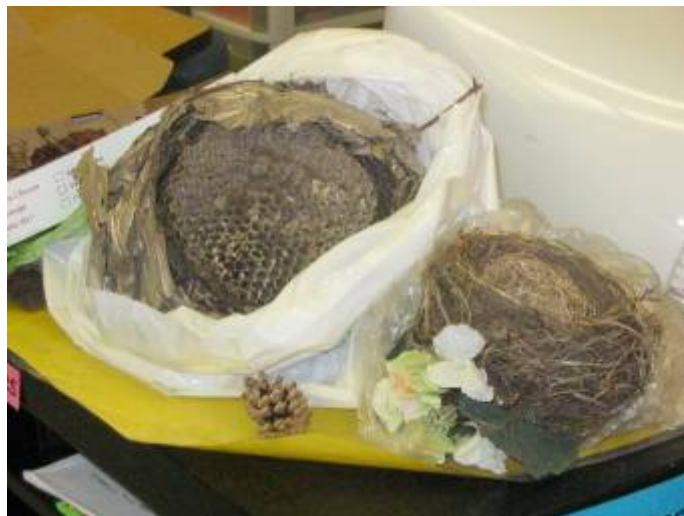
Picture 22

Bird and insect nests were observed in a classroom (Picture 22). Nests can contain bacteria and may also be a source of allergenic material. Nests should be placed in resealable bags to prevent aerosolization of allergenic material.

Bird and Insect Nests

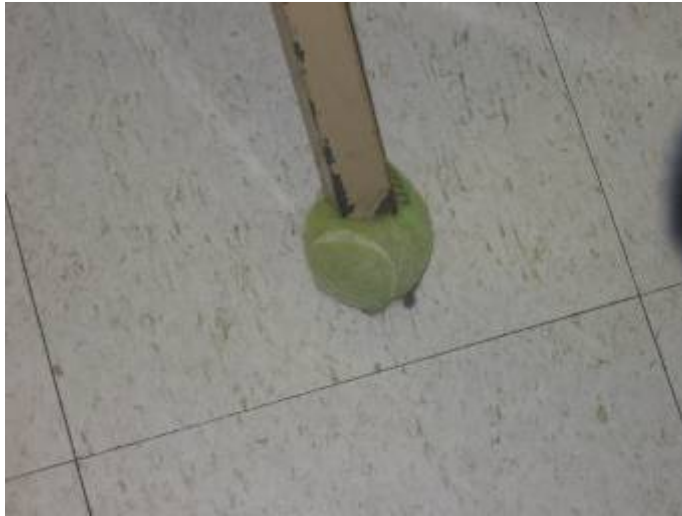
Picture 23

In an effort to prevent scratching from sliding desks, tennis balls had been sliced open and placed on the desk legs (Picture 23). Tennis balls are made of a number of materials that are a source of respiratory irritants. Constant wearing of tennis balls can

produce fibers and cause TVOCs to off-gas. Tennis balls are made with a natural rubber latex bladder, which becomes abraded when used as a chair leg pad. Use of tennis balls in this manner may introduce latex dust into the school environment. Some individuals are highly allergic to latex (e.g., spina bifida patients) (SBAA, 2001). It is recommended that the use of materials containing latex be limited in buildings to reduce the likelihood of symptoms in sensitive individuals (NIOSH, 1997).

Tennis Ball on Desk Leg

17. Replace latex-based tennis balls with latex-free tennis balls or rubber booties.
18. Consider adopting the US EPA document, “Tools for Schools” to maintain a good indoor air quality environment on the building (US EPA, 2000). This document can be downloaded from the Internet at: <http://www.epa.gov/iaq/schools/index.html>.
19. Refer to resource manuals and other related indoor air quality documents for further building-wide evaluations and advice on maintaining public buildings. These materials are located on the MDPH’s website: http://mass.gov/dph/indoor_air.

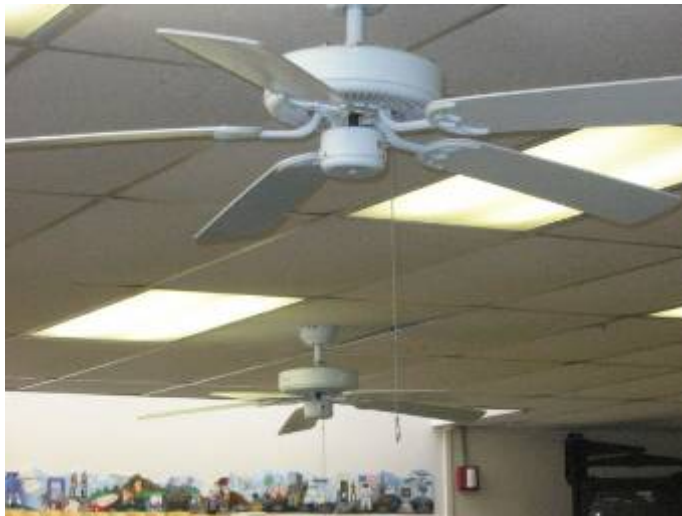
Picture 24

Airflow in many classrooms is supplemented by ceiling fans (Picture 24). These ceiling fans should be used to aid in air circulation within the room, especially during warmer months when windows are open. It is important to note that before operating, ceiling fans must be cleaned of dust buildup. Accumulated dust on the fan blades can aerosolize causing irritation to eyes and respiratory system.

Ceiling Fans in classrooms
